# **Effectiveness of Street Sweeping in Incline Village, NV**

Final

December 2011

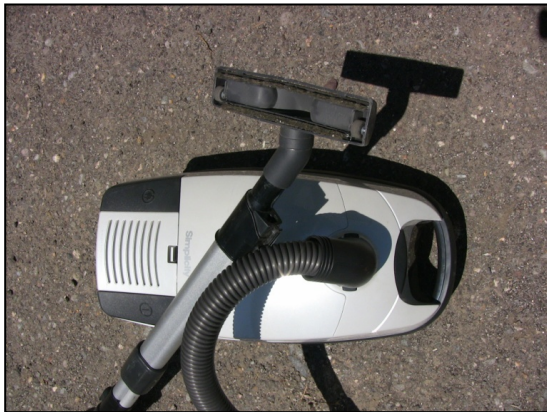
Figure 2. The Simplicity S36 vacuum cleaner and the 8-inch vacuum head used for this study.

The Simplicity model S36 “true-HEPA” household vacuum was used to sample road sediment (Figure 2). Most studies have used canister-type shop vacuums to vacuum dry road sediment (Rochfort et al. 2007, Deletic and Orr 2005, USGS 2003, USGS 2007, Selbig and Bannerman 2007, Bannerman 1983, and Pitt 1979), and other studies have used wet sampling to collect road sediment (Rochfort et al. 2007, Deletic and Orr 2005). Shop-type vacuums are generally larger than household vacuums, with larger diameter hoses capable of collecting larger material, and configured to move a greater volume of air than household vacuums. However, for this study the authors felt that vacuum performance measured as “sealed pressure,” reported in vertical inches of water, was more important than volume of air because the greater pressure creates more shear stress between the vacuum head and the road surface and therefore was better suited to recover sediment. The Simplicity S36 had a sealed pressure rating of 100 inches whereas a Shop-Vac brand 5-gallon “drywall” vacuum had a sealed pressure rating of 64 inches and the Shop-Vac “professional” series had a rating of 75 inches. In addition, Simplicity vacuum had other advantages including more secure connections between the hose, wand, head, and canister unit, and the option to use a fabric micro-filtration bag.

The Simplicity S36 was equipped with two filters: one before the fan assembly and a HEPA filter after the fan. The filter before the fan remained in place throughout the experiment to protect the fan from accidental ingestion of large material, but the HEPA filter was removed to ensure a constant flow of air.

An 8 inch-wide vacuum head was selected that had horsehair brushes in front and back to create a seal between the vacuum head and road. Wheels, 3/4 inch in diameter, were located on either side of the head assembly and allowed the head to move smoothly over the road while maintaining a constant gap to the road. Because the brushes would wear, the head was periodically replaced. Over the course of the two-year study, six identical vacuum heads were used.

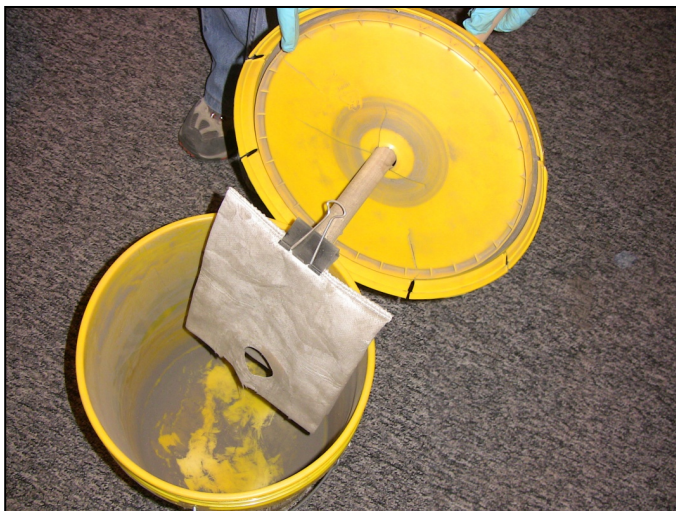
Figure 3. The apparatus used to shake the vacuum bags.

After collection, each bag was dried at 25° C for at least 3 days. The dry sample weight was used in subsequent data analysis. To process the sample, bags were cut open and contents emptied into a 5-gallon bucket. The top was placed on the bucket and the emptied bag shaken using a configuration similar to a butter churn (Figure 3). The sediment was removed from the bucket and dry sieved for 3 - 4 minutes using three 8-inch sieves (Table 1) shaken by a Gilson Company, Inc. model SS-15 sieve shaker. No more than 250 grams of sediment was sieved at a time. The <600  $\mu\text{m}$  sediment fraction was bagged, weighed, and sent to the Desert Research Institute (DRI) for LPSA (see Table 1 for the bin sizes).

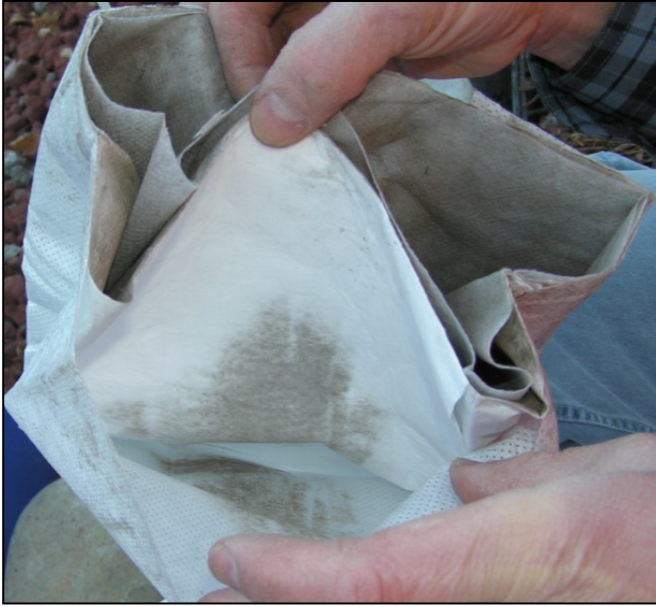
Figure 4. Three plies in the micro-filtration vacuum bag.

LPSA was performed by a Saturn Digisizer laser backscatter system that accurately analyzed size fractions of  $600 \mu\text{m}$  or less. The results of the LPSA analysis, the dry sieve data, and mass of sediment in each vacuum bag were proportionally combined in a spreadsheet.

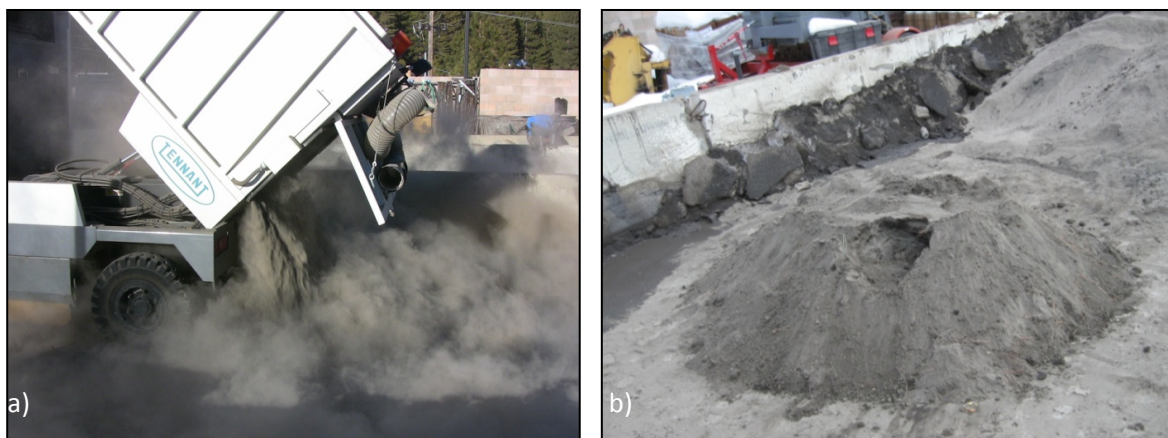
Figure 7. The Tennant Sentinel street sweeper a) dumping sediment and b) the resulting sediment pile.

The bulk sweeper pile usually contained a considerable volume of pine needles and pine cones. To determine the aggregate density for a typical sweeper load, bulk samples were collected in 5 gallon buckets on 23 Jun 2009 and 23 March 2010 to determine an average bulk density of  $1.36 \text{ g/cm}^3$ . The sweeper sediment samples were dried, sieved, and the  $<600 \text{ }\mu\text{m}$  size fraction sent to DRI to be analyzed for LPSA (Table 1).

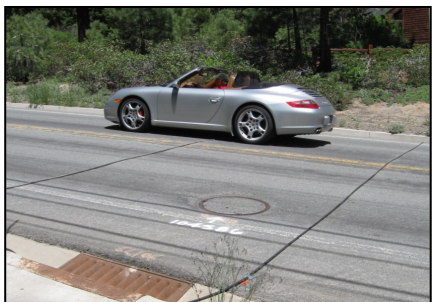
Figure 9. Traffic tubes on Village Blvd.

Traffic volume, as noted in the introduction, is a critical component in the mass per unit area and transformation of particle size. Traffic volume was measured in the Harold study area on three occasions and once in the Ace study area using a TimeMark Inc. Gamma pneumatic tube system (Figure 9). The data were collected over a five to nine day period in early summer when there was little risk of a snowplow or sweeper damaging the tubes.

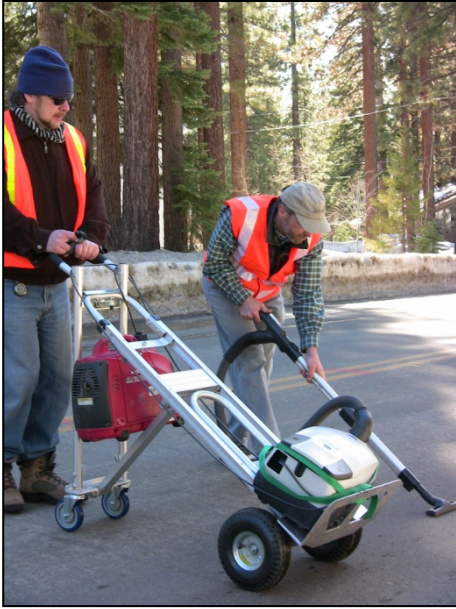
Figure 12. Vacuum operations on Village Blvd.

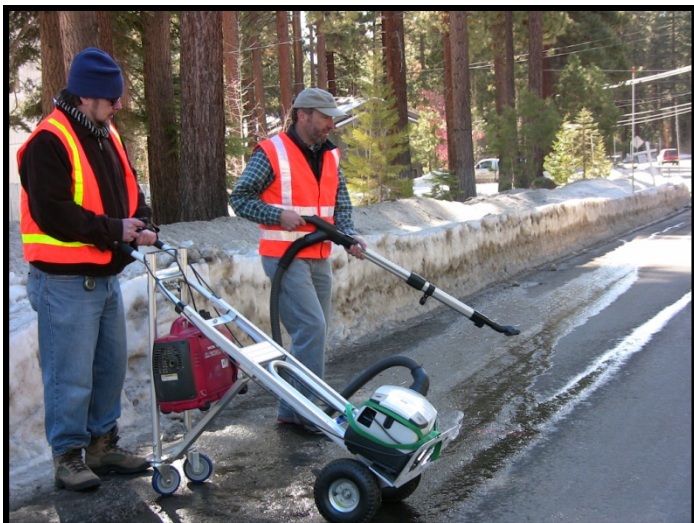
Figure 13. Snow in the curb and water on the road prevented curb-to-curb samples.

When snow or melt water covered sections of the road, only the dry areas were vacuumed and swept (Figure 13). No effort was made to estimate the area of the road not swept, but the length of a transect that could not be vacuumed was measured. The fraction of all the transects that could not be vacuumed was assumed to be representative of the area of the road that could not be swept.

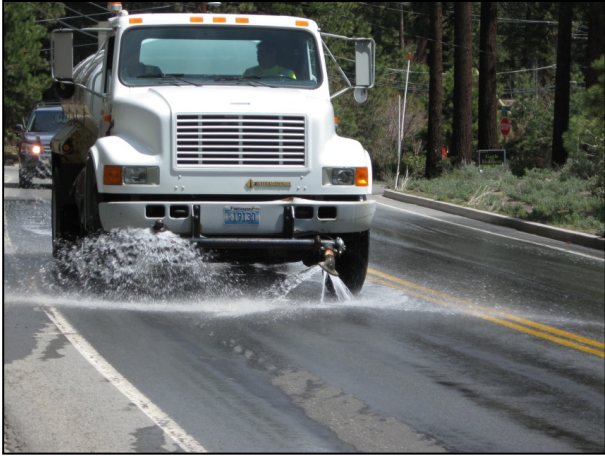
Figure 15. The Washoe County 2,000 gallon water truck discharging on Village Blvd. during a washoff experiment.

Approximately 10,000 gallons or 5 loads from the water truck were discharged on Harold and 12,000 gallons or 6 passes on Ace were required to achieve the half-inch of water on Ace. The experiments were conducted on 22 March 2010 and 1 June 2010. Various discharge combinations of sprayers and gravity dump were used on the truck until the correct rate was found. When the spray nozzles were used, water was not sprayed outside the curb.

The procedure used on 22 March was to fill the truck at the hydrant on Ace Ct. then discharge the water during a single trip from Ace Ct. to Harold Drive and back while maintaining a constant speed (or from Ace Ct. to the top of the Ace study area and back). It was found that a single round trip with the water truck generated very high peak flows and resulted in 10,000 gallons being discharged in 70 minutes at Harold. A slower discharge rate was used for the 1 June washoff experiment by traveling two full circuits of Village Blvd. for each study area to empty the water truck.

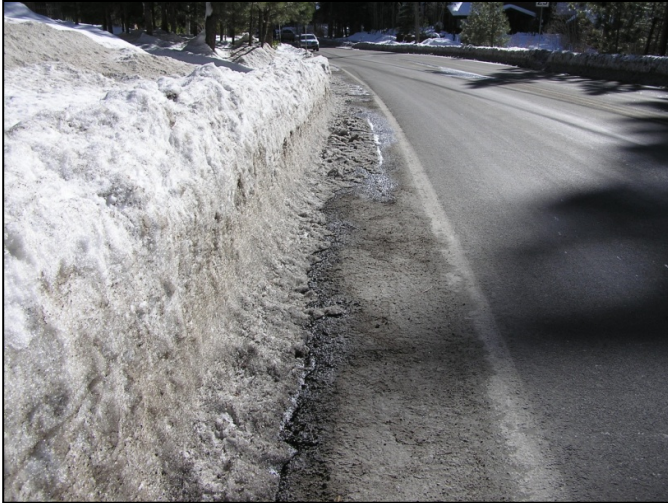
Figure 32. The curb area of Village Blvd. in the winter. The entire concrete gutter is covered with about 3 vertical feet of snow and ice containing road sediment.

Another less obvious consequence of curbs is that less snow is removed from the road. During snow removal operations, road maintenance crews avoid damaging curbs by maintaining a buffer between the plow blade and the curb. On Village Blvd. this practice frequently resulted in snow 2 to 3 feet deep and 1 to 2 feet into the road, despite attempts by the road maintenance personnel to keep the gutter clear for this experiment (Figure 32). The amount of snow and ice in the road is documented by this study by the inability to vacuum to the curb on many occasions (Table 9). As the snow in the road melts, water flows where the majority of sediment is located—along the curb—and moves that material to the stormwater outfall where it becomes a treatment issue. The melting snow also prevents the street sweeper from accessing the gutter where the majority of sediment is located. The remaining sediment in the gutter is available to be mobilized during larger runoff events (e.g., rain on snow). Without a curb, the snow is generally cast completely off the road where melting snow can infiltrate into the soil. Curb and gutter likely have a place in the Tahoe Basin, but the disadvantages should be more thoroughly considered before installation.
